Subject: Enforcement Action against Jim Jones, Noelani Yacht Charters, LLC, Kevin S. Albert, Kimberly L. Albert, and the Albert Revocable Trust for Stony Coral and Live Rock Damage resulting from the *Nakoa* grounding incident on February 20, 2023 outside of the Honolua-Mokulē'ia Bay Marine Life Conservation District, island of Maui.

Nakoa Vessel Grounding, Lipoa Point
Maui Damage Assessment
Field Investigative Report
April 20, 2023

Field Investigation Report
Initial Field Assessment 2/21/2023
Final Assessment 3/7/2023
Final Report Completed 4/20/2023

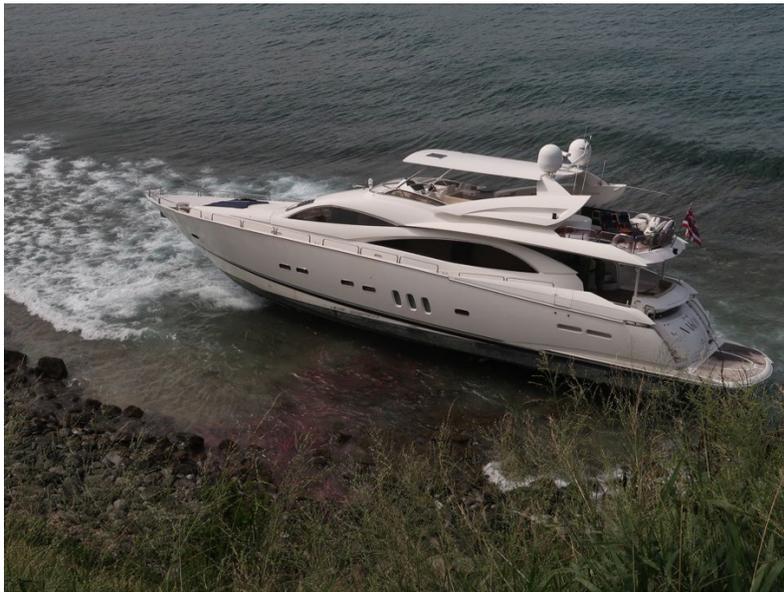
The Vessel “Nakoa” shown grounded on the rocky shoreline and leaking diesel fuel.

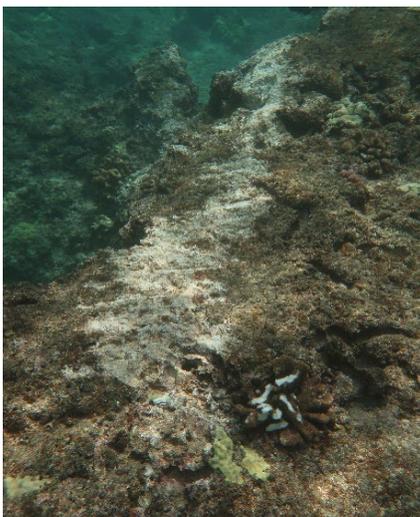
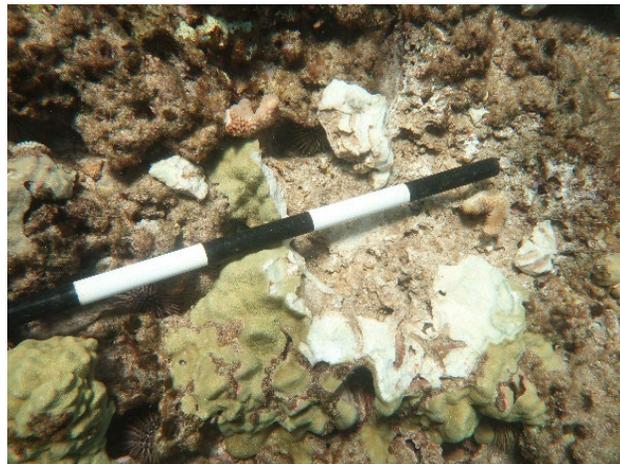
Examples of damage to live rock habitat and corals from the grounding and salvage operations.

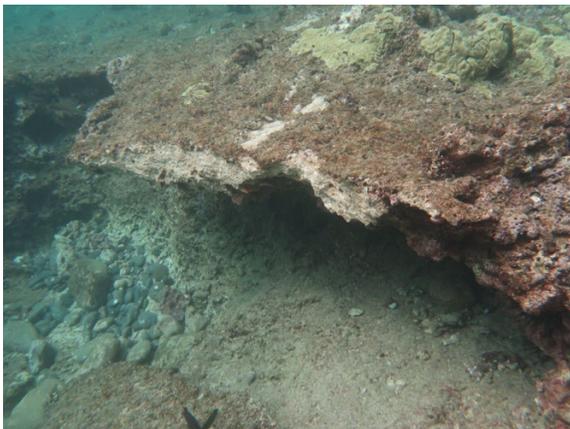
The initial grounding incident resulted in a patchy impact scar extending 85 meters by 2 meters from a northwestern direction (170 square meters). Of this total 170 square meters of disturbed habitat, 35.5 square meters of clearly damaged high rugosity live rock habitat was specifically documented and photographed (Figures 1 & 2). In addition, there were 18 coral colonies directly damaged or destroyed during this grounding. All damaged coral colonies were individually documented during the initial grounding inspection and consisted of 8 colonies of *Pocillopora meandrina* (“cauliflower coral”) and 10 colonies of *Porites lobata* (“lobe coral”).

Figure 1: Photograph of an underwater shelf habitat broken off from impacts during the grounding of the vessel “Nakoa”.

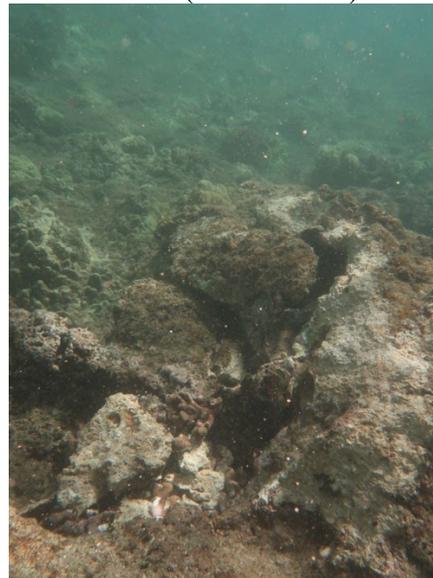
Figure 2: Photograph showing a section of structured habitat Smashed by the grounding event.

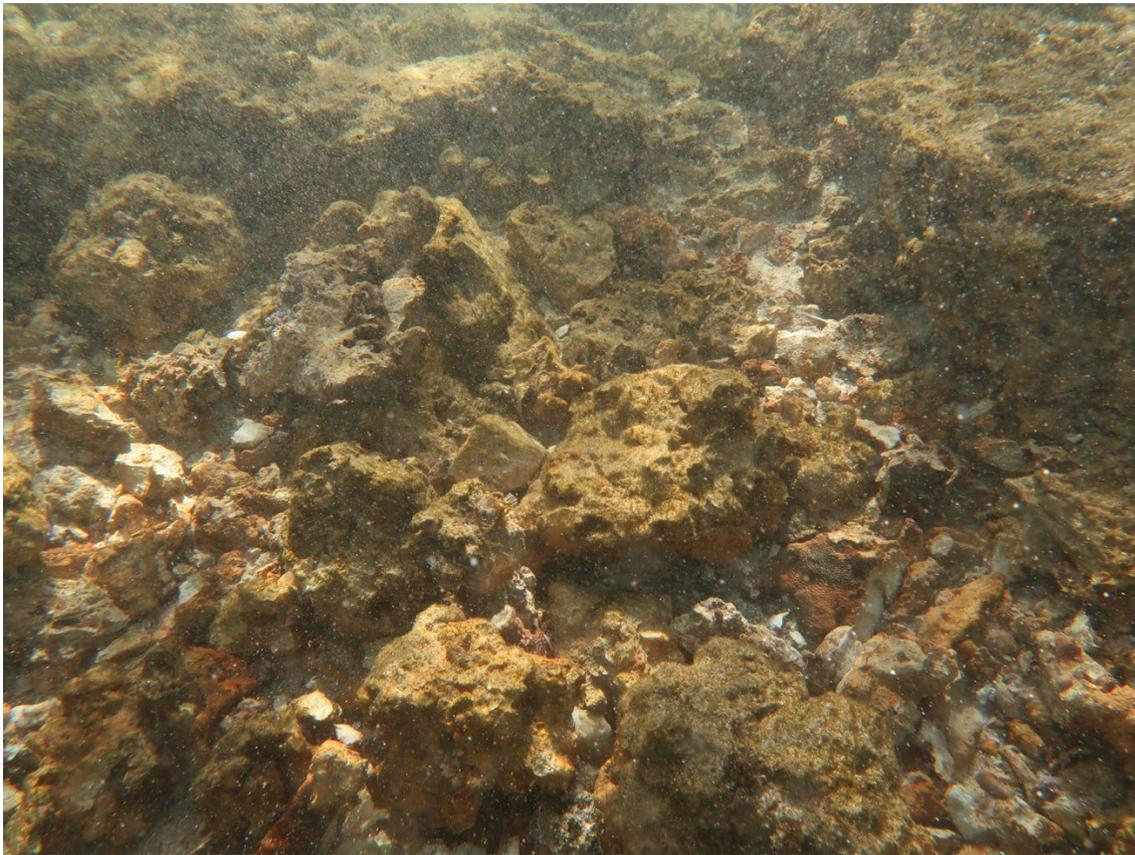
The vessel then remained grounded in extremely shallow water along a basalt boulder shoreline for 14 days while salvage efforts were planned and the pollutants were removed. This area where the vessel remained stranded was composed of flat carbonate pavement and basalt boulder habitat in a high wave energy environment. In this area, a total of 1,575 square meters of live rock habitat was scarred, smashed and/or disturbed (45m long by 35 m wide) (Figure 3). There

were very few live coral colonies found in this area and the substrate was covered mostly by turf algae.

Figure 3: Underwater photograph showing the damage to hard bottom substrate at the location where the Nakoa was grounded for 6 days.

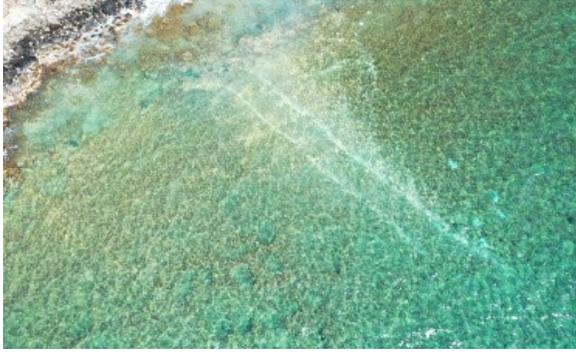
The final salvage removal operation that was conducted on Sunday, March 5, 2023, resulted in a scar to the substrate that extended an additional 75 meters in a westerly direction from where the vessel was stranded. The initial 15 meters of this salvage scar consisted of two deep trench-like scars that were about 5 meters apart and were each 1 meter wide (Figures 4 & 5). This was followed by a smaller impacted area for the next 60 meters that was limited to about 2 meters of width and extended out to a final depth of 10 feet. Within the deeper habitat, the damage was patchy and mostly composed of damage to individual coral colonies. The combined hard bottom live rock substrate impacted by this salvage scar was 195 square meters. There were significant impacts to living coral colonies all along this total salvage scar area, but the most significant impact to the live rock habitat was along the two scars that each extended 15 m x 1 m (30 square meters). Coral colonies impacted included 77 colonies of *Pocillopora meandrina* (“cauliflower coral”) and 24 colonies of *Porites lobata* (“lobe coral”) for a total of 101 impacted coral colonies within the salvage scar.

Figure 4: Aerial Photograph showing the two parallel salvage scars leading offshore from site. (photo by: Mark Deakos)

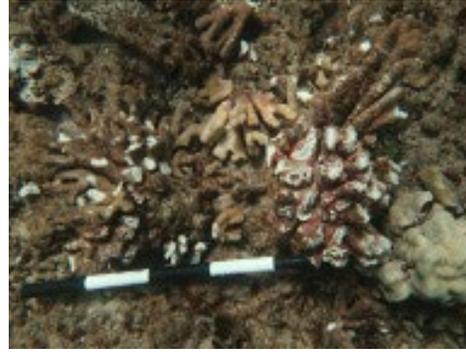
Figure 5: Underwater photograph showing coral damage along the grounding salvage scar.

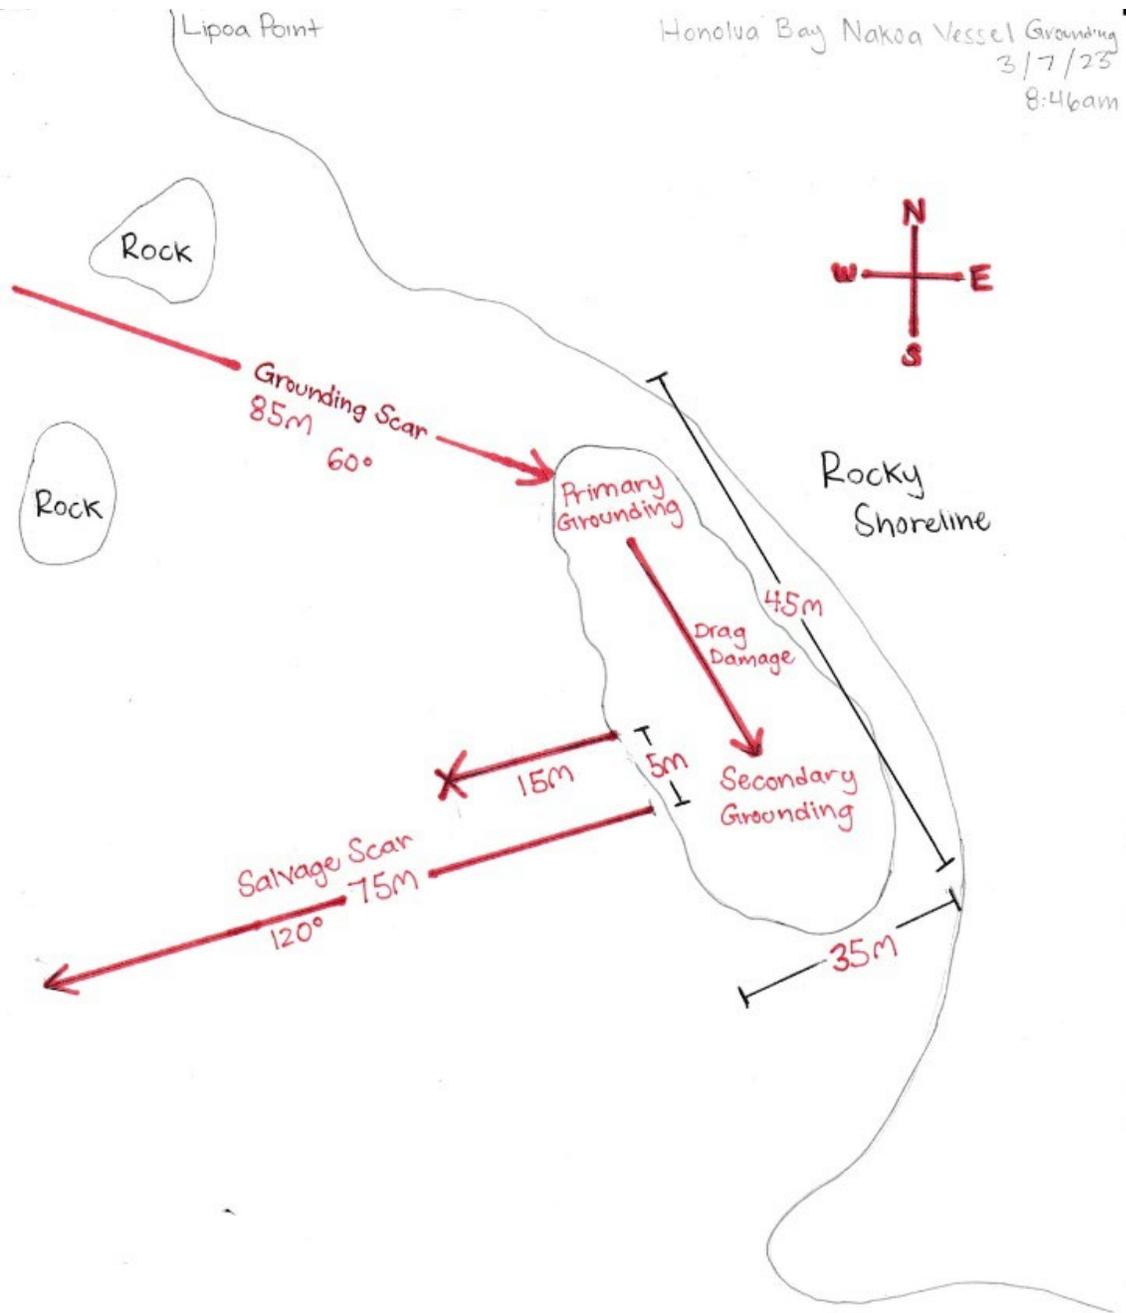
Figure 6: Detailed map of the impact area. The map shows the Initial Grounding Scar, the salvage scar, and the secondary grounding scar (where the vessel sat for 14 days along the shoreline).

The entire grounding and salvage incident resulted in impacts to 1,940 square meters of hard bottom nearshore habitat. Of that total impacted area, we focused our assessment on important habitats with significant and highly visible damage to live rock and on all damage to individual colonies of live corals. Key areas of damaged live rock included: 35.5 square meters of damage to high rugosity live rock habitat that occurred on the initial grounding scar; 1,575 square meters of smashed and damaged shallow hard bottom pavement and basalt boulder habitat where the vessel grounded and moved around in the waves; and 30 square meters of damage where the vessel was dragged out to deeper water resulting in deep scars into the shallow flat pavement habitat in the area. This entire impacted area is covered with highly cropped turf algae and patchy coral cover.
